DEPARTMENT OF TRANSPORTATION**DIVISION OF ENGINEERING SERVICES**

Contract #: 04-0120F4Cty: SF/ALA Rte: 80 PM: 13.2/13.9File #: 69.28**WELDING INSPECTION REPORT****Resident Engineer:** Pursell, Gary**Address:** 333 Burma Road**City:** Oakland, CA 94607**Report No:** WIR-002770**Date Inspected:** 02-Jun-2008**Project Name:** SAS Superstructure**OSM Arrival Time:** 630**Prime Contractor:** American Bridge/Fluor Enterprises, a JV**OSM Departure Time:** 1530**Contractor:** Zhenhua Port Machinery Company, Ltd (ZPMC), Changxing Island **Location:** Shanghai, China**CWI Name:** Ye Yong Jun and Shazhi**CWI Present:** Yes No**Inspected CWI report:** Yes No N/A**Rod Oven in Use:** Yes No N/A**Electrode to specification:** Yes No N/A**Weld Procedures Followed:** Yes No N/A**Qualified Welders:** Yes No N/A**Verified Joint Fit-up:** Yes No N/A**Approved Drawings:** Yes No N/A**Approved WPS:** Yes No N/A**Delayed / Cancelled:** Yes No N/A**Bridge No:** 34-0006**Component:** OBG abd SAS Tower Fabrication**Summary of Items Observed:**

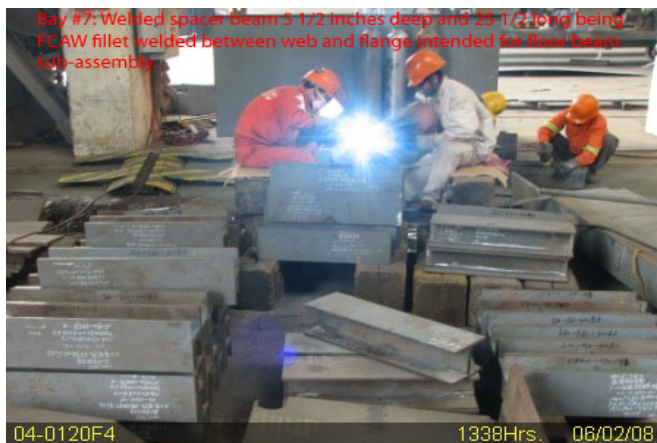
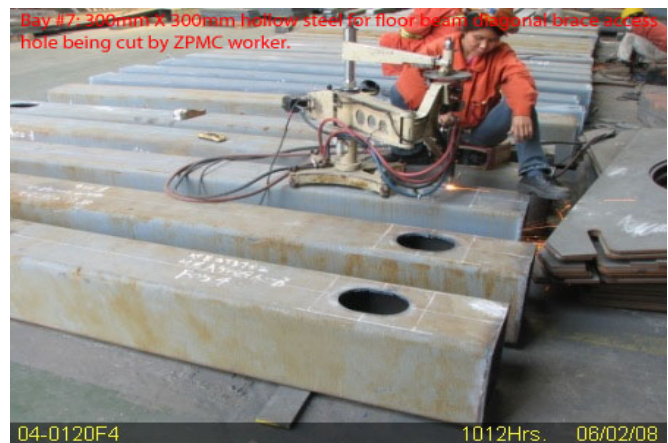
This QA Inspector observed FCAW fillet welding on stiffener to web plate on longitudinal diaphragms LD010-002-003/004 and LD003-006-003/004 by two ZPMC welders Xie Chen Fu ID# 045236 and Xiao Wen Yuan ID#058482 utilizing WPS-B-T-2331-Tc-P4-F.
